# Effects of Concentrated Hydrochloric Acid Spills on Aircraft Aluminum Skin

July 1998

DOT/FAA/AR-TN97/108

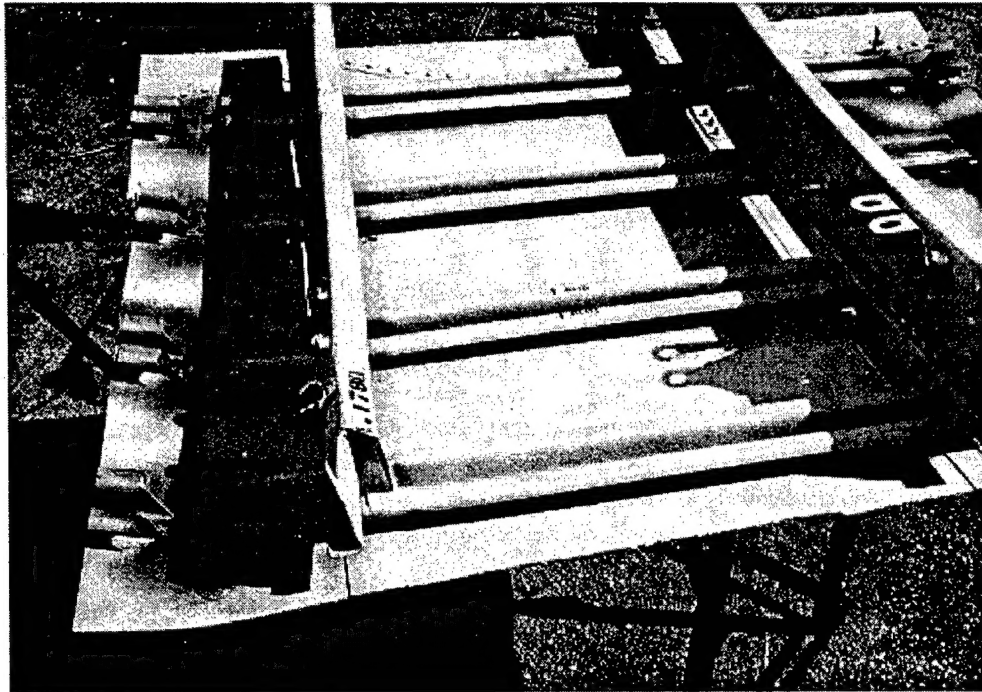
The first test was the largest, a 3- by 3-foot section with a 1-liter acid spill (figures 1 and 2). The edges of the skin were bent upwards to contain the acid. In the process of bending the skin and cutting notches in the ribs to allow the bending of the frame, scrapes and breaks in the surface coating of the aluminum skin were produced. There was no treatment of the marred surfaces in this test. The acid contacted not only the interior skin surface but also the bulkhead plates and fittings and the ribs and attaching grommets.

FIGURE 1. TEST ARTICLE FOR TEST 1: 3- BY 3-FOOT SIDEWALL OF A BOEING 747

Test No.	Test Article Description	Location of Failure	Time to Failure (min.)	Comments	Figure No.
1	3' x 3' section of fuselage	At scratched surfaces and at bends in skin  At rivets	47, 65, and 80  No failure	Acid created hole in skin at scratched and bent surfaces.  Rivets partially decomposed, but still intact.	1, 2
2	6" x 6" section of aluminum skin in a 7" x 7" Pyrex pan	At rivets  At ribs   At rivets	50  70  80  85	Three rivets eaten away below surface of skin.  Side of rib eaten 1/2 inch through the length of rib. Severe corrosion.  All submerged surfaces of unpainted rib completely gone.  Only white exterior paint remained where rivets were.	3
3	7" x 7" section of aluminum skin as base of pressurized box, 0-2.5 psi. Silicone caulk used as a seal.	At rivets  At ribs	N/A    90	Severe corrosion. Rivets eaten through below surface of the skin.  Rib disconnected from aluminum skin. All submerged surfaces of unpainted rib completely gone. Base seal remained intact.  Pressure not maintained during the test due to failure of lid seal.	4, 5, 6

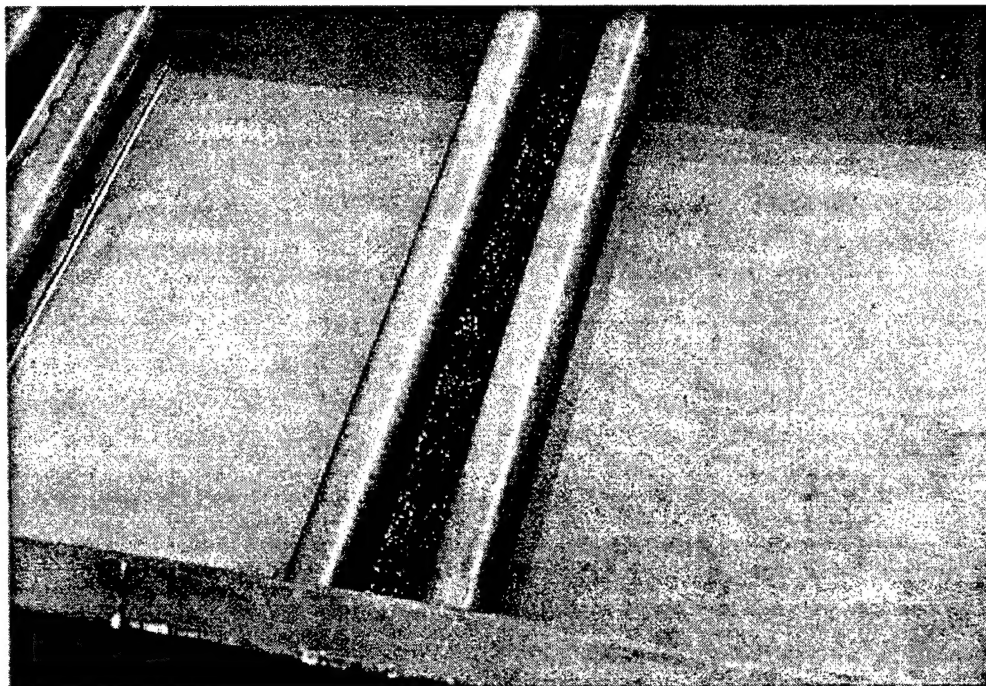
FIGURE 2. TEST 1 IN PROGRESS WITH A 1-LITER SPILL OF CONCENTRATED HYDROCHLORIC ACID

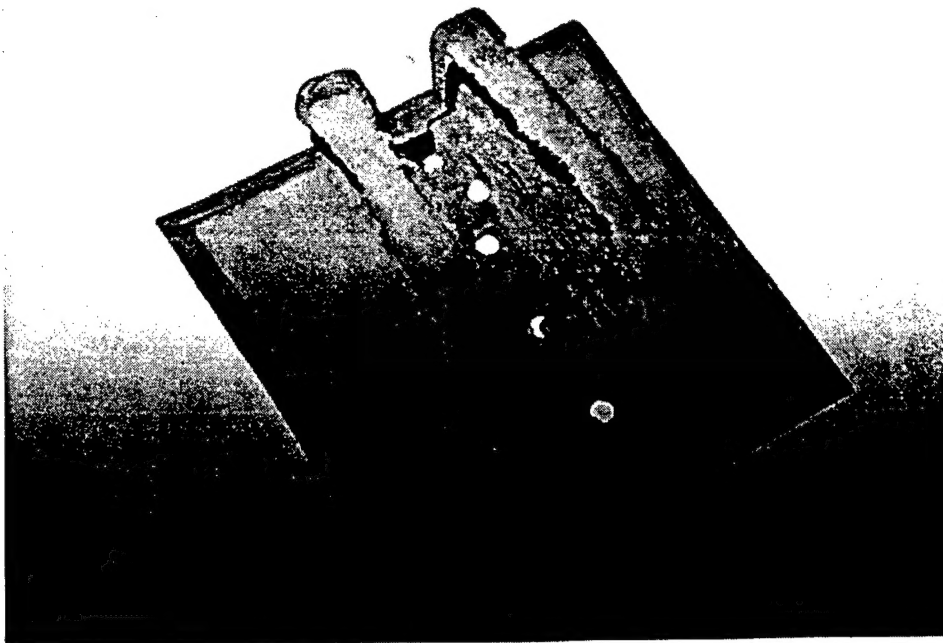
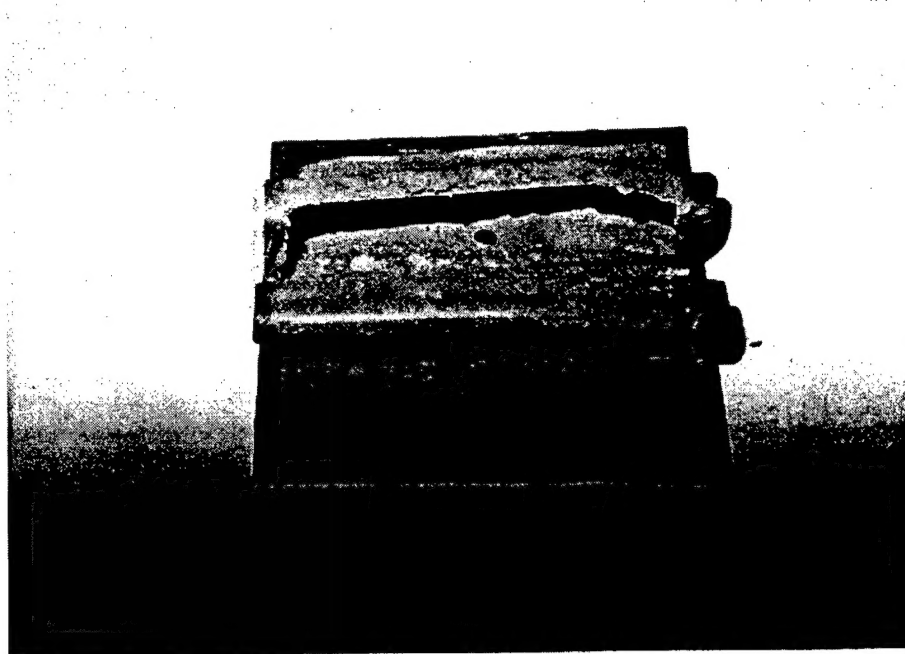
A 6- by 6-inch section of the skin, including the frame material, was placed in a Pyrex pan with the outside surface of the skin face down. All cut edges of the test sample were covered with epoxy paint. One liter of concentrated HCl was spilled into the Pyrex pan. The depth of acid was 1 1/4 inches. Periodically the section of skin was lifted out of the solution with metal tongs to visually evaluate the damage as a function of exposure time. The test specimen was rinsed with tap water at the conclusion of the test and photographed (figure 3).

**FIGURE 3. TEST ARTICLE FOR TEST 2 AFTER REMOVAL FROM PYREX PAN  
CONTAINING 1 LITER OF CONCENTRATED HYDROCHLORIC ACID, TWO VIEWS**

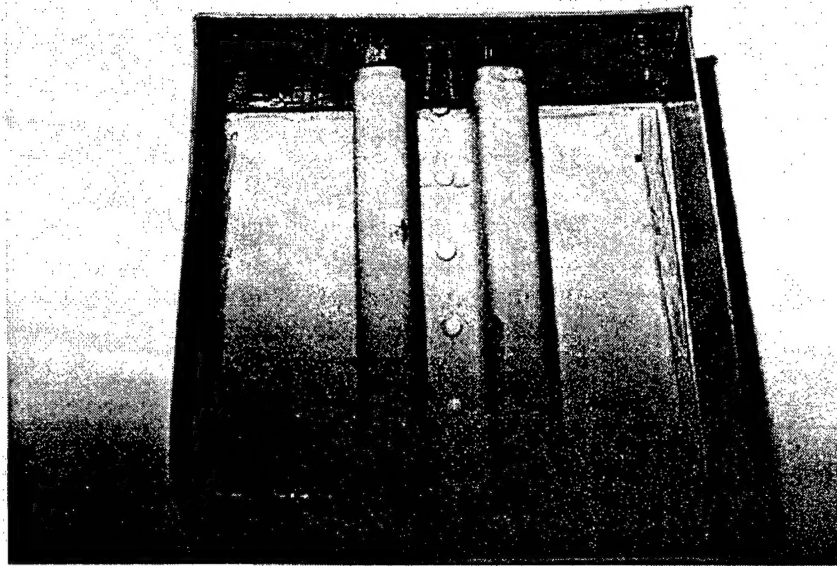
A 7- by 7-inch section of aluminum skin was used as the base of a box (figures 4, 5, and 6). All cut edges of the test sample were covered with epoxy paint. The test specimen was caulked to the bottom of a shallow aluminum box with silicone caulk. The bottom of the box was cut out to be slightly smaller than the test specimen resulting in a high-contact surface of the silicone caulk with both surfaces. An epoxy coated metal lid was caulked in place over the aluminum box. The lid contained two Teflon swagelok bulkhead unions. The box was pressurized with nitrogen from 0 to 2.5 psi.

FIGURE 4. TEST ARTICLE FOR TEST 3 PRIOR TO ACID SPILL

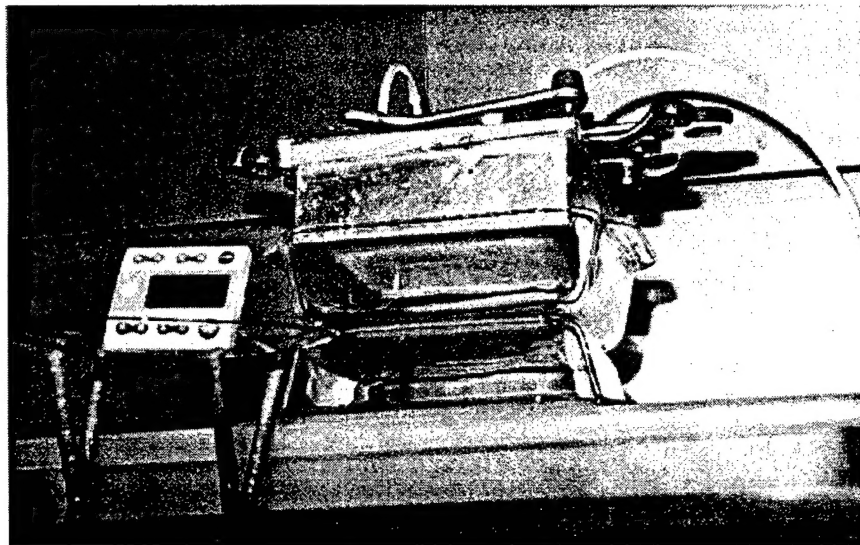
FIGURE 5. TEST 3 IN PROGRESS WITH A 1-LITER SPILL OF CONCENTRATED HYDROCHLORIC ACID

A 2.5 psi box pressure simulates the  $\Delta P_{\text{skin}}$  at 15,000 feet altitude. A small  $\Delta P$  may result in the blowout of the white exterior epoxy paint on the bottom of the box when the rivets fail, giving a visual indication of failure. However, the silicone lid seal failed early into the test and pressure fell to ambient.

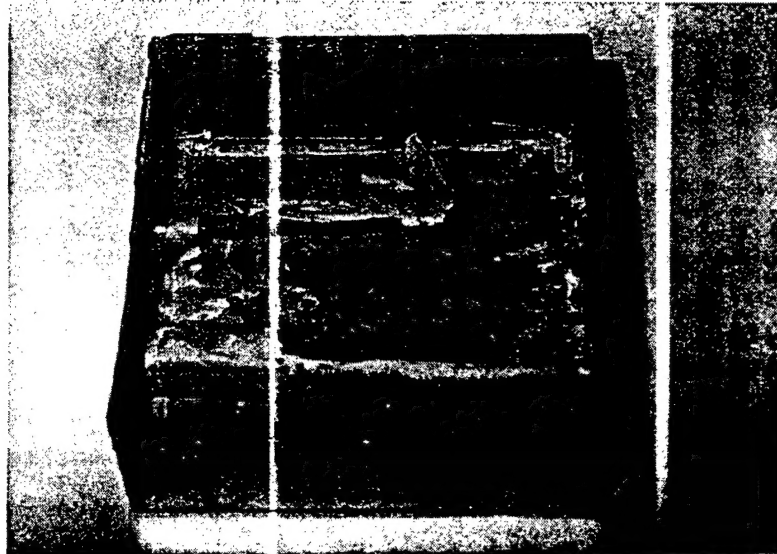
FIGURE 6. TEST ARTICLE FOR TEST 3 AFTER A 90-MINUTE CONTACT WITH SPILLED CONCENTRATED HYDROCHLORIC ACID. TOP OF TEST CONTAINER REMOVED.
